March 17, 2020

RE: Report of 2020 Lake Sediment Probing
Swan Lake

Swan Lake
Lake Sediment Assessment

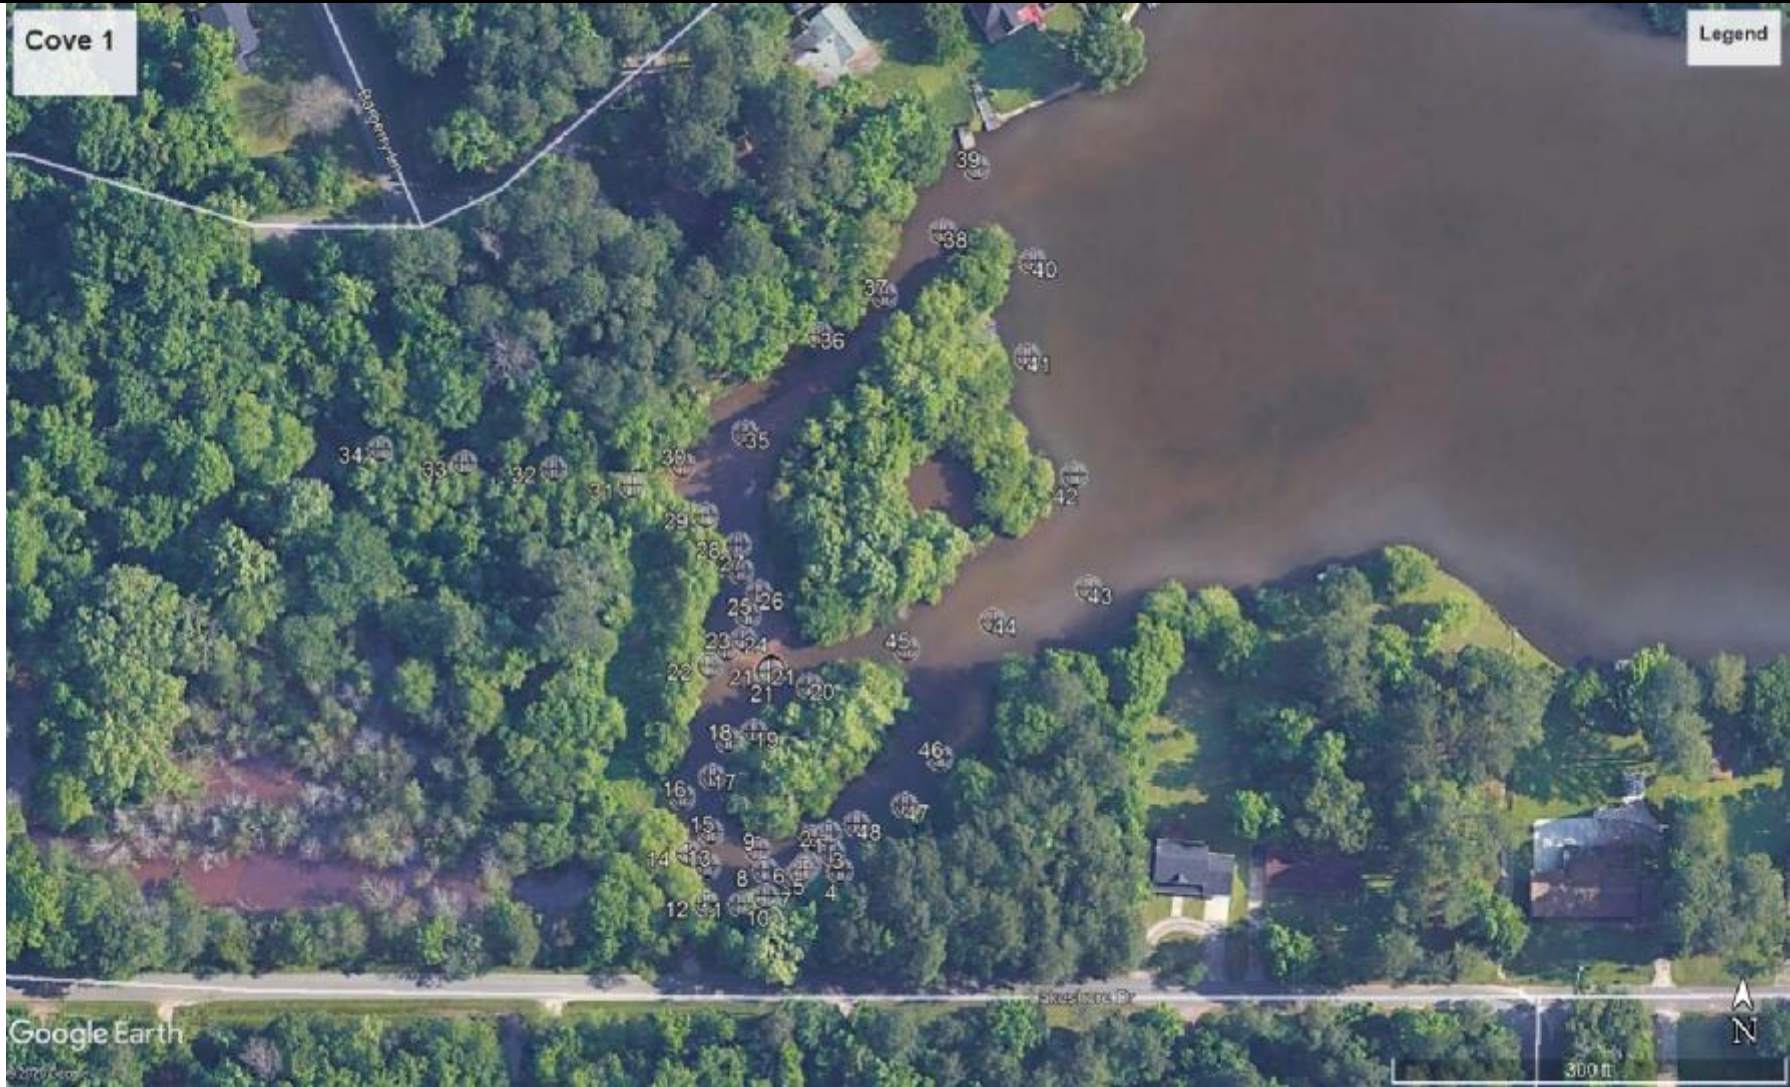
Figure 3 – Cove 1

Study Year	2020
Cove 1 Surface Area (acres)	1.94
Measurement Stations	1-48
Number of Data Points	48
Average Water Depth (Feet)	1.02'
Range of Water Depths (Feet)	0.00' – 3.75'
Average Sediment Thickness (Feet)	4.82'

The data obtained during this investigation has identified an average water depth of 1.02 feet within Cove 1 (Stations 1-48) and 3.17 feet within Cove 2 (Stations 49-62). Further analysis of the data shows that the measured average sediment thicknesses of 4.82 and 3.13 respectively within each study area accounts for approximately 82% volume loss within Cove 1 and 49% volume loss within Cove 2. The data collected

The data obtained through the course of this investigation suggests that dredging operations for the impoundment should be planned for in the near future. This viewpoint is based upon the fact that the volume of each inlet cove study area is over 50% full of sediment and the average water depth is less than 4 feet. Our investigation has determined an annual accumulation rate of approximately 232 cubic yards for Cove 1, assuming no dredging efforts have been conducted since the ponds construction. As a general rule, the cost to remove sediment material from a pond is in the range of \$35 to \$55 per cubic yard. However, the cost can vary depending on factors such as disposal area and accessibility.

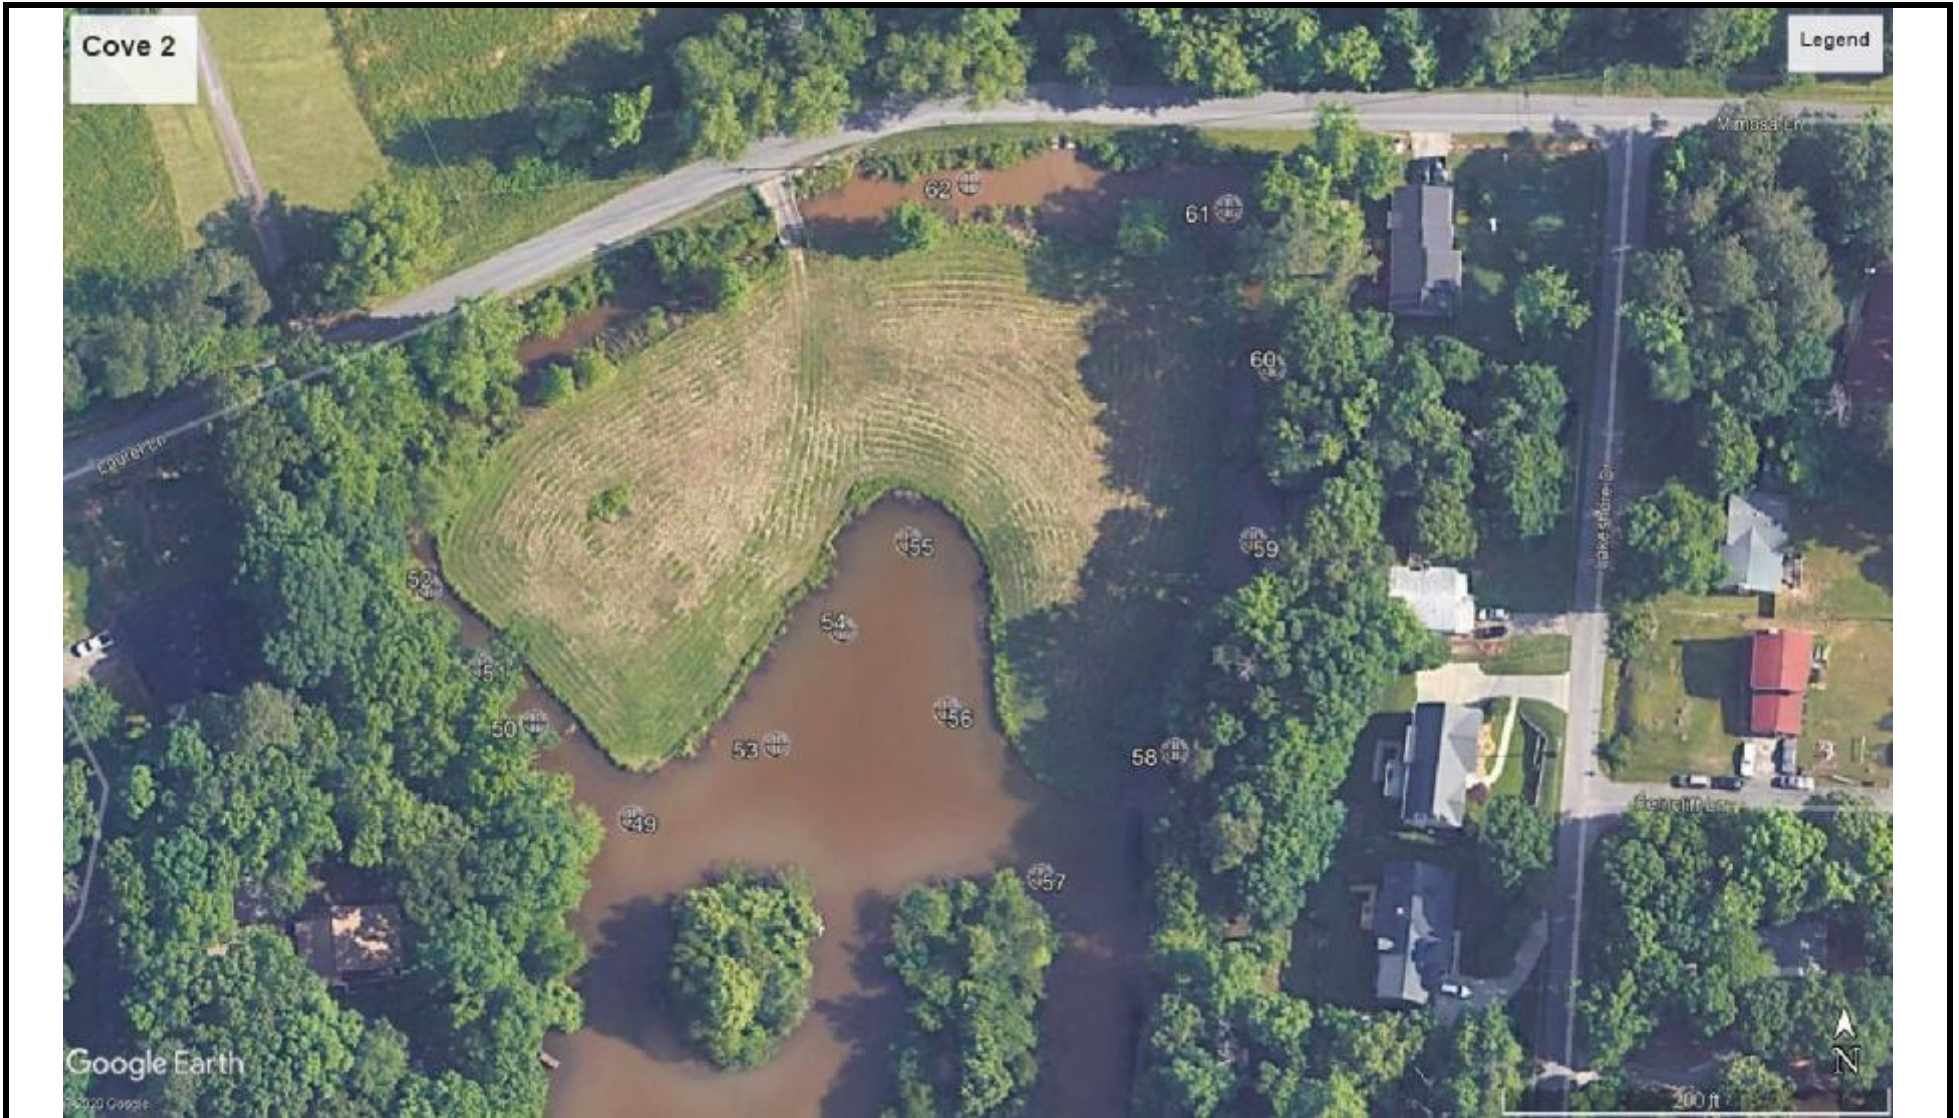
Figure 2 – Cove 2

Study Year	2020
Cove 2 Surface Area (acres)	1.68
Measurement Stations	49-62
Number of Data Points	13
Average Water Depth (Feet)	3.17'
Range of Water Depths (Feet)	1.90' – 4.85'
Average Sediment Thickness (Feet)	3.13'
