March 17, 2020

RE: Report of 2020 Lake Sediment Probing
Swan Lake

Swan Lake
Lake Sediment Assessment

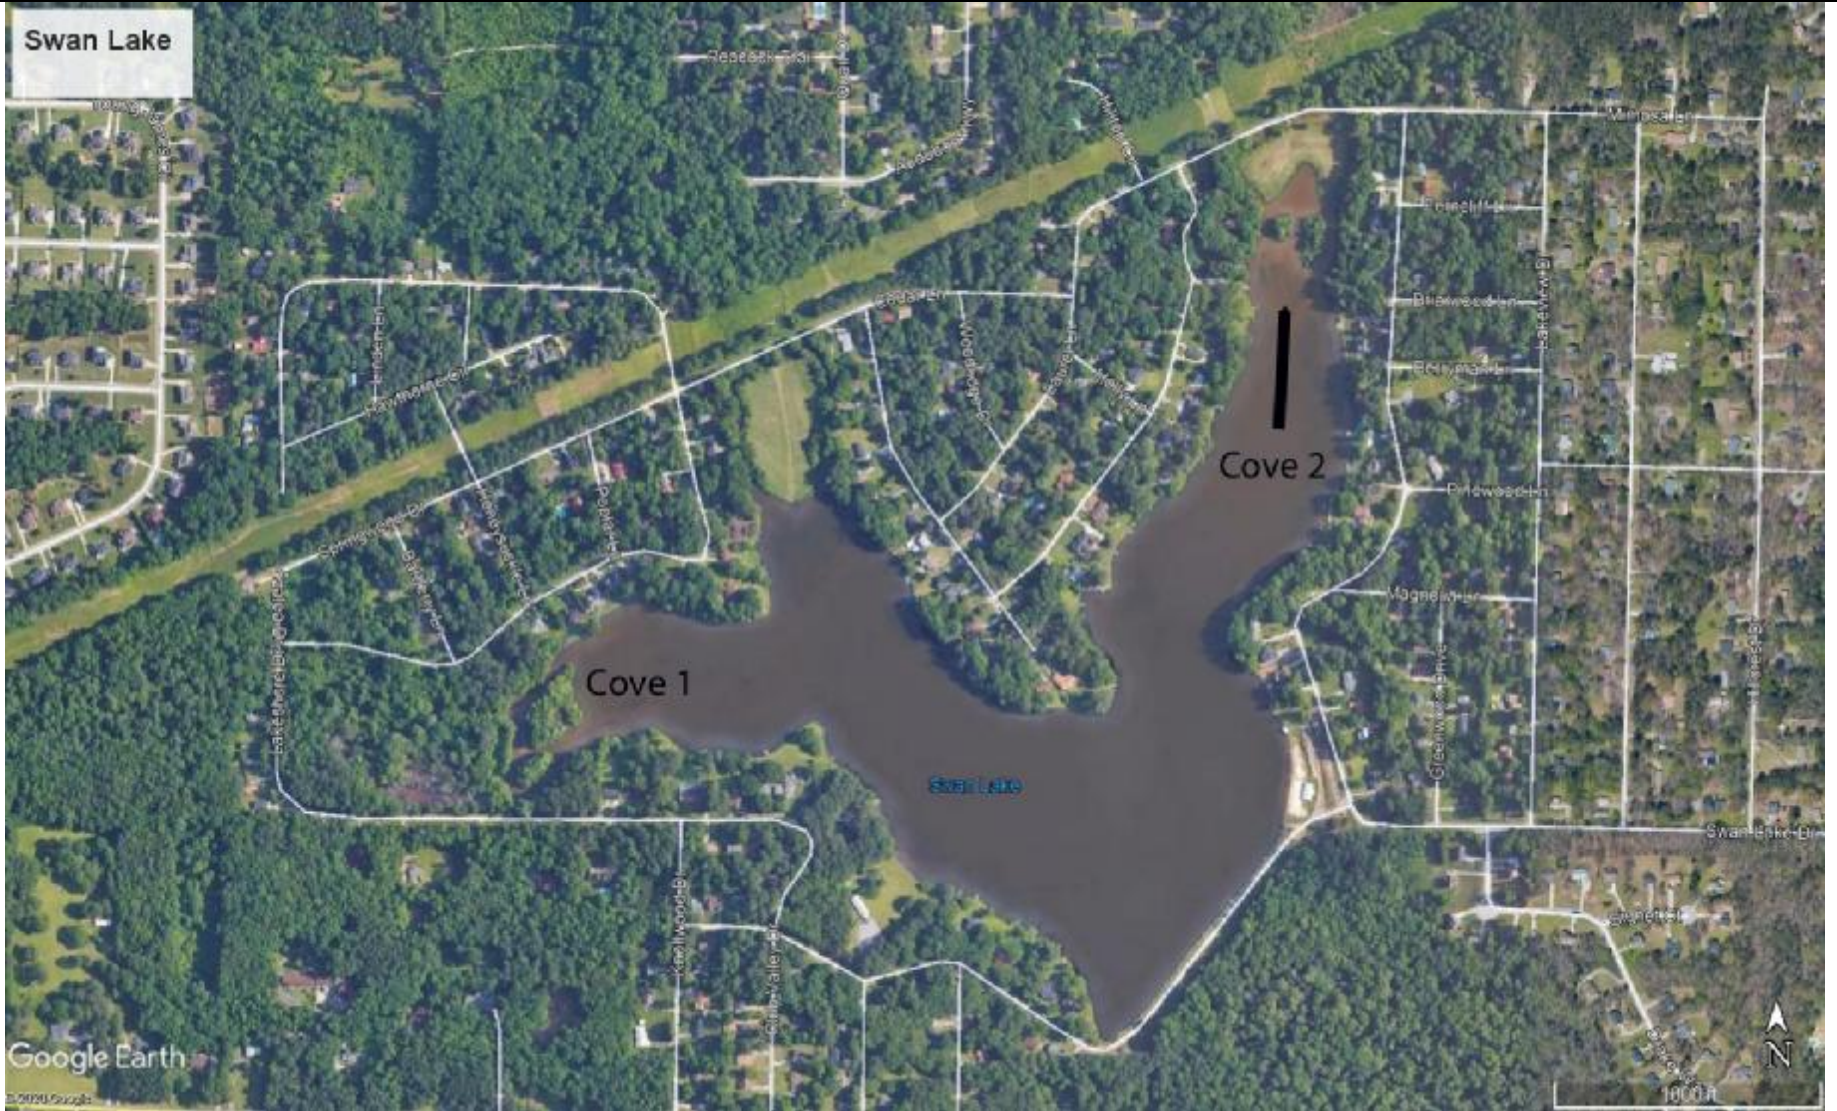
Figure 2

Each data point station was recorded using a Trimble Geo7X Global Positioning System receiver. This system utilizes a 12-channel integrated GPS/Beacon/Satellite Differential receiver and antenna to record point position data with an accuracy of less than one meter horizontal. Integrating real-time differential GPS (DGPS) into the system is necessary for accurately relocating these stations in the event that future field activities are required. This system was also used to construct a map of the study area, identifying the data points collected. The locations of each random probe can be seen on the attached schematic diagram of the impoundment (Figure 2).

Random Probe Location Map
